CLIENT: The Trustees of the Sompting Estate

PROPERTY: The Downs Barn, Lambleys Lane, Sompting BN14 9JX

REPORT DATE: 15 May 2015

1 Instructions

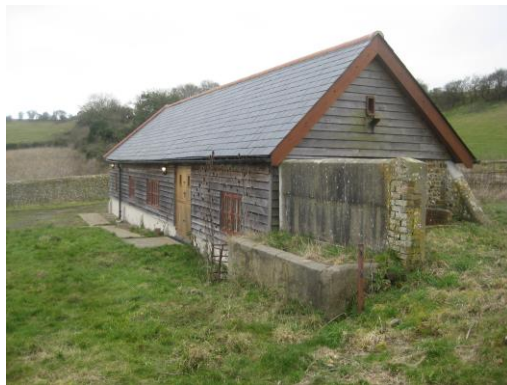
North and east elevations

The Downs Barn comprises a detached, single storey former agricultural building of timber framed and timber clad construction under a slate covered roof which has been converted to form a venue for meetings and study purposes.

The building comprises a principal room, a study, store room, kitchen and WC/shower room. There is one entrance/exit comprising a double door on the eastern elevation as shown in the photographs below.
